SL0010 WAGO Connector Block orientation

SL0010	Version 1	SmartLift	10 July 2006
--------	-----------	-----------	--------------

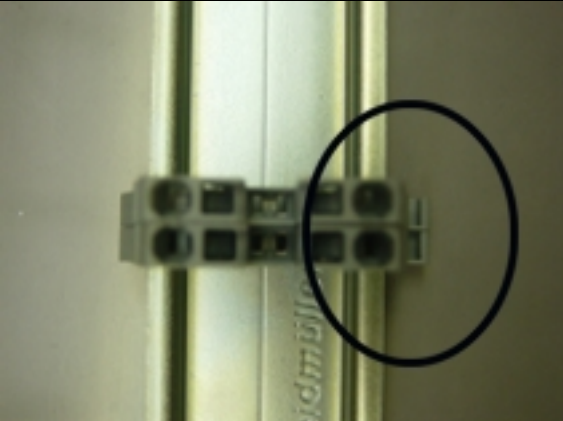
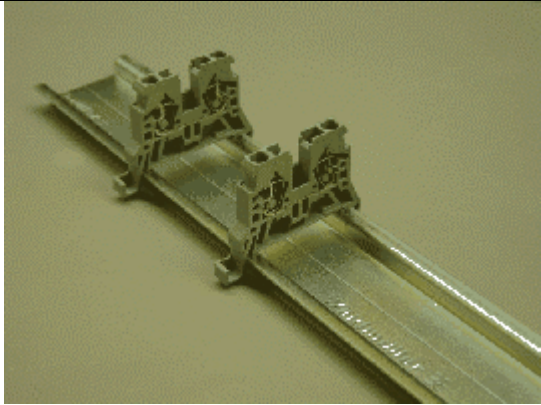
<p>Correct – Release Tabs on same side (View from above)</p>	<p>Correct -Blocks facing same way</p>

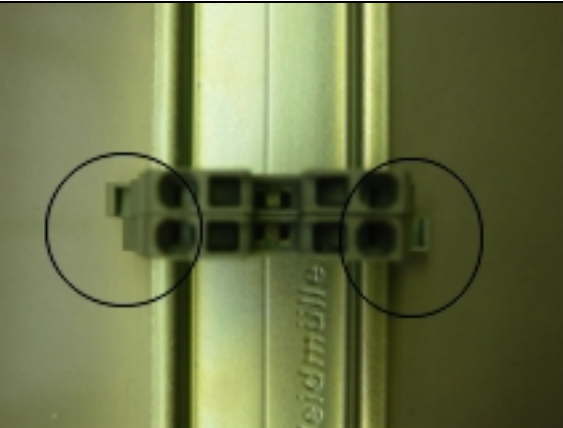
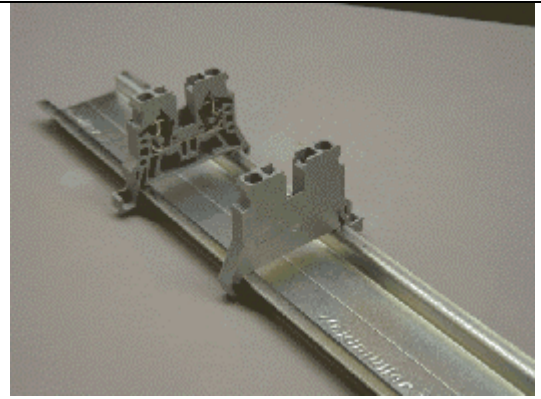
<p>Incorrect – Release Tabs on opposite sides (View from above)</p>	<p>Incorrect - Blocks facing opposite ways.</p>

Incorrect orientation of WAGO junction blocks results in circuits shorting intermittently, which in turn causes electrical faults. The faults caused depend on which blocks are shorting.

Faults caused by incorrectly orientated blocks are more likely to occur when there is high moisture, as moisture provides a path between the blocks causing them to short. Therefore, as an example, a fault may occur early on a winter morning, but not in the middle of the day.

The easiest way to identify an incorrectly orientated block is to look at the positions of the release tabs (See photos above).

If the tabs are not all on the same side of the DIN rail, then a block (or blocks) are orientated incorrectly.

1. Take note of the wires going into the block and which holes they are in.
2. Release wires using a small flathead screwdriver pushed firmly into the relevant release slot.
3. Release the block using small flathead screwdriver pushed down and out on release tab.
4. Re-fit block in correct orientation
5. Re-connect wires into the block.
