SL0021 SMARTlift Top Arm Angle Sensor Cable Service

Date: 18 Oct 07	Author: Richard Brown	SMARTlift	Version 1
-----------------	-----------------------	-----------	-----------

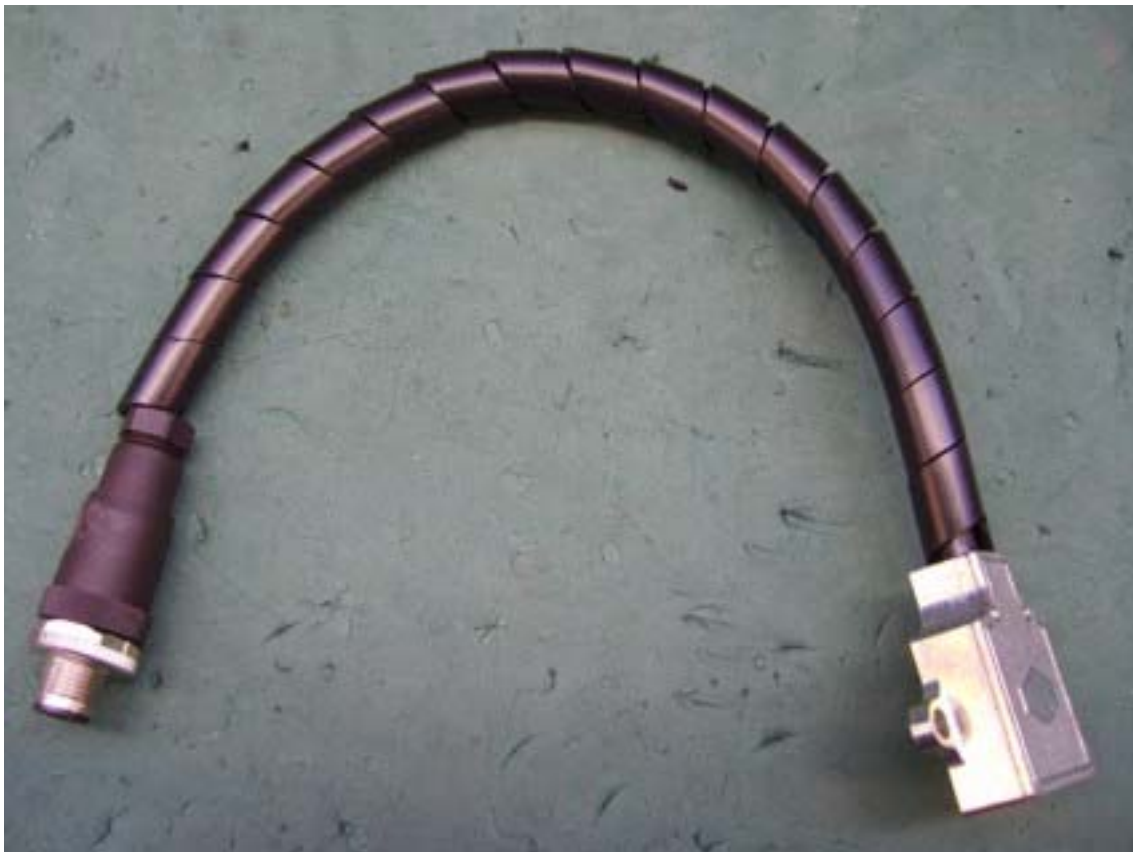
At next service please add 12mm Spiralflex to the Top Arm Angle Sensor Cable to prevent the cable from becoming trapped and crushed between the Top Arm Cylinder Rod Eye and the inside of the Top Arm Fabrication.

The symptom of a possible crushed angle sensor cable will be a blown Angle Sensor Ground 2A fuse in the module junction box. This may cause other Angle Sensors Errors to be displayed too.

Cable shown with 12mm Spiralflex added.
