## S0036 Wear Pad replacement on SB330

S0036 Version	1 Structural	30-3-07
---------------	--------------	---------

Procedure for the replacement of wear pads on model SB330

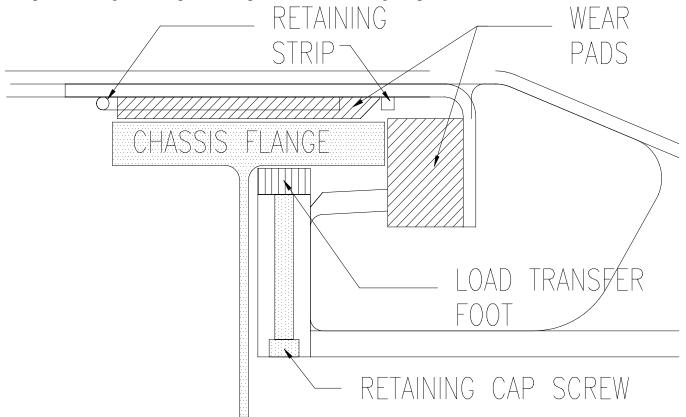
The wear pads mounted under the SB330 crane base are designed to run dry and do not require greasing however a regular inspection is required. If there are any unusual sounds coming from the module area and/or there is excessive clearance between the load transfer feet and the flange, the wear pads should be inspected.

If the clearance between the load transfer foot and the chassis flange is greater than 4mm the pads should be replaced with genuine replacement parts. Please note original pads are 10mm thick.

- 1. Position the two crane assemblies to the 20' position.
- 2. Unbolt the load transfer foot from the base assembly. This will allow the crane base assembly to be raised sufficiently above the top flange to remove and replace the wear pads.
- 3. To access the " Non loading side":
- 4. Raise the bottom and top arms to their maximum extension (you will need to enter Manual Override Mode to do this) while stabilizers are off the ground. This allows the crane base to rise and the old pads can now be replaced. Lower the top and bottom arms and ensure that the wear pads are correctly located in their cavity.
- 5. To access the "Loading side":

- 6. Tilt the stabiliser leg up to its maximum position and then extend the stabiliser extension until the crane base rises allowing the replacement of the wear pads. Slowly retract the stabiliser extension and ensure that the wear pads are correctly located in their cavity.
- 7. Refit the load transfer foot once the new pads are in place. Inspect the clearance between the load transfer foot and the chassis flange. If the clearance is greater than 1mm the load transfer foot must be shimmed to attain this dimension. Torque cap screws to 45Nm.
- 8. Test run the Sidelifter and ensure pads remain in their correct positions and that there are no unusual noises coming from the base assembly area.
