SL0013 Faulty Terminal Jumper

SL0013	Version 1	SMART <i>lift</i>	22 Sept 06
--------	-----------	-------------------	------------

This service info applies to all Digital Control and Smartlift trailers.

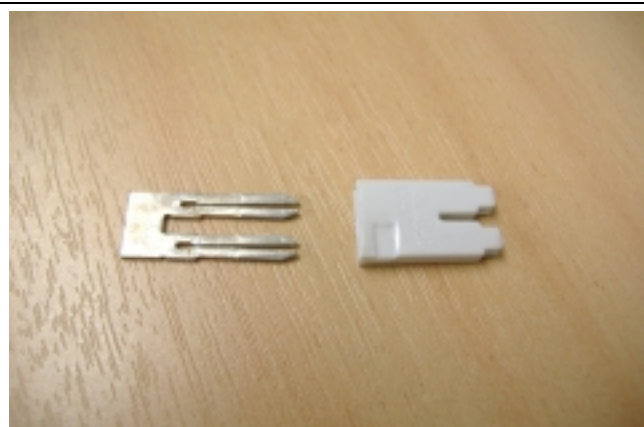
These two jumpers are essential to Can Bus operation, they are located in the rear junction box which contains the LCD screen.

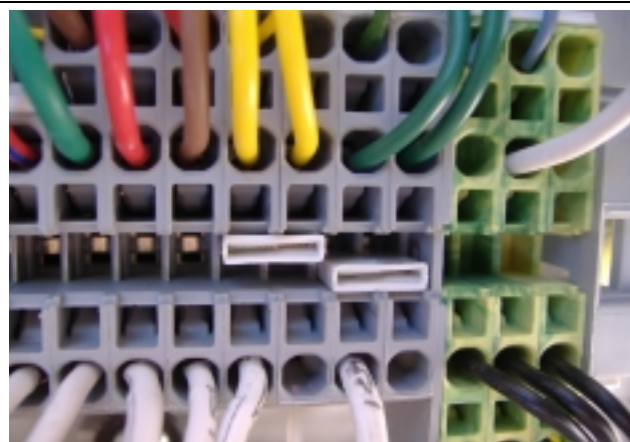
The jumper is manufactured from two separate pieces. The metal insert is simply pushed into the plastic housing.

On one occasion the metal insert has pushed up in the plastic housing when the jumper was inserted to the wago block, causing a very poor connection.

Make sure that the metal insert is pushed fully down when fitting the jumper. The insert should be about 4mm inside the plastic outer.
