TB0041 Drainage holes on SB121 High Crane Base

Date: 28 Nov 2005

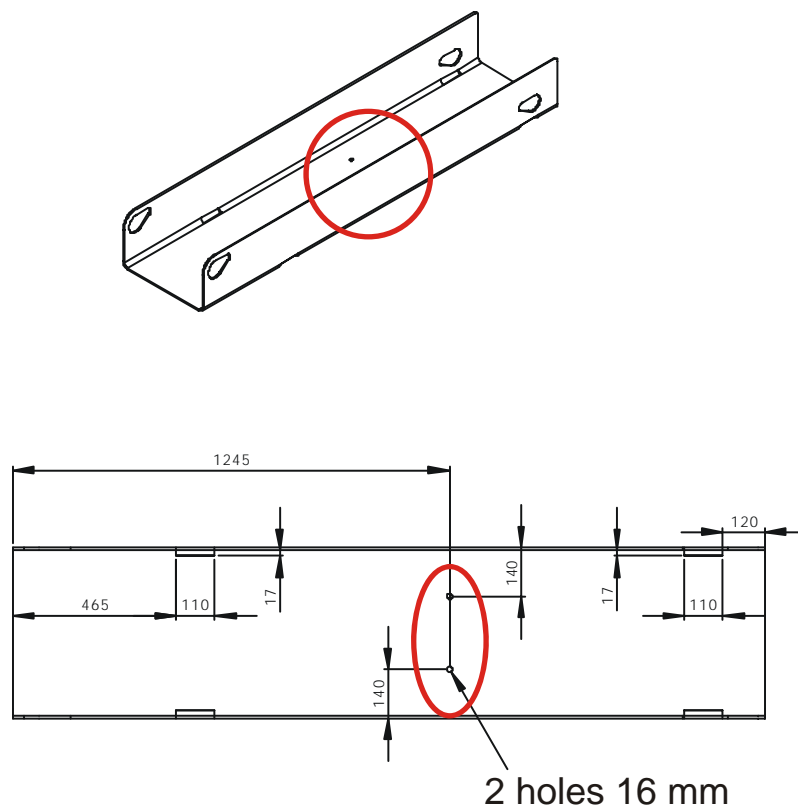
We have added two dia 16mm holes to the drawing S2-32493 (now rev C) to overcome reported problem of rainwater build-up inside the high crane base.

See red circled areas in drawing.

Holes can be added by service agents per our instructions
